TURBINE TIP CLEARANCE MEASUREMENT

Lawrence C. Baker, Gordon E. Grady, Hagen R. Mauch

General Electric Company
Aircraft Engine Group
1000 Western Avenue
Lynn, Mass. 01910

March 1978

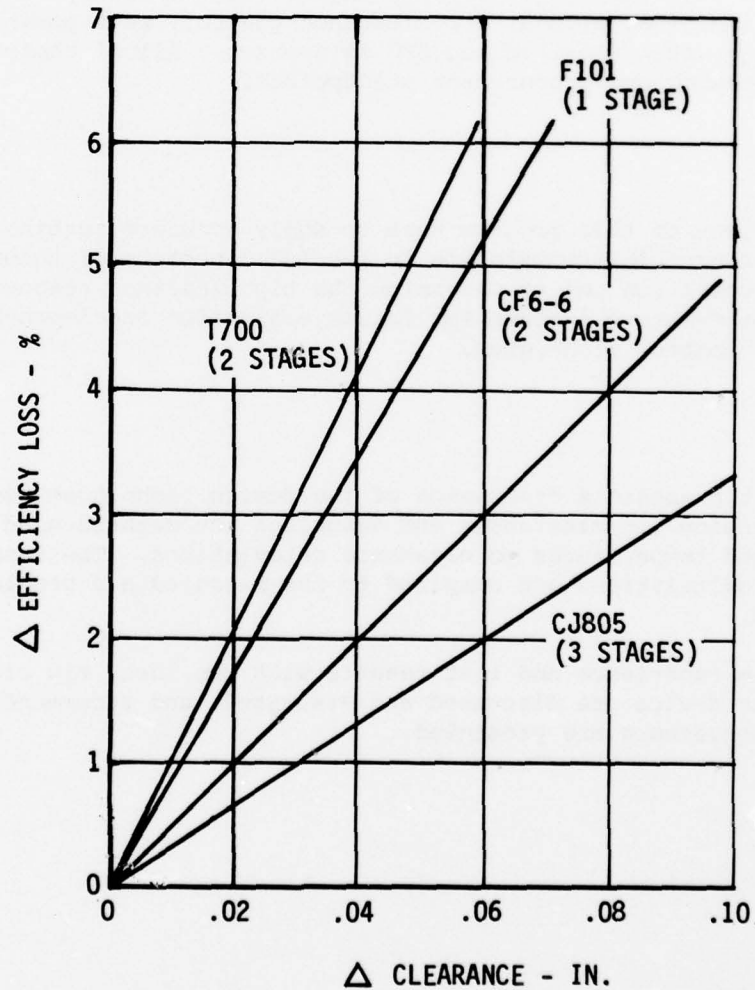
Figure 1. High-Pressure Turbine Efficiency Loss With Tip Clearances.

Since clearance at the airfoil tips is a major source of component aerodynamic performance loss, there is a need to minimize the average tip clearance of a turbine blade stage. Figure 1 shows the effect of clearances on turbine performance for a variety of engine sizes and configurations.

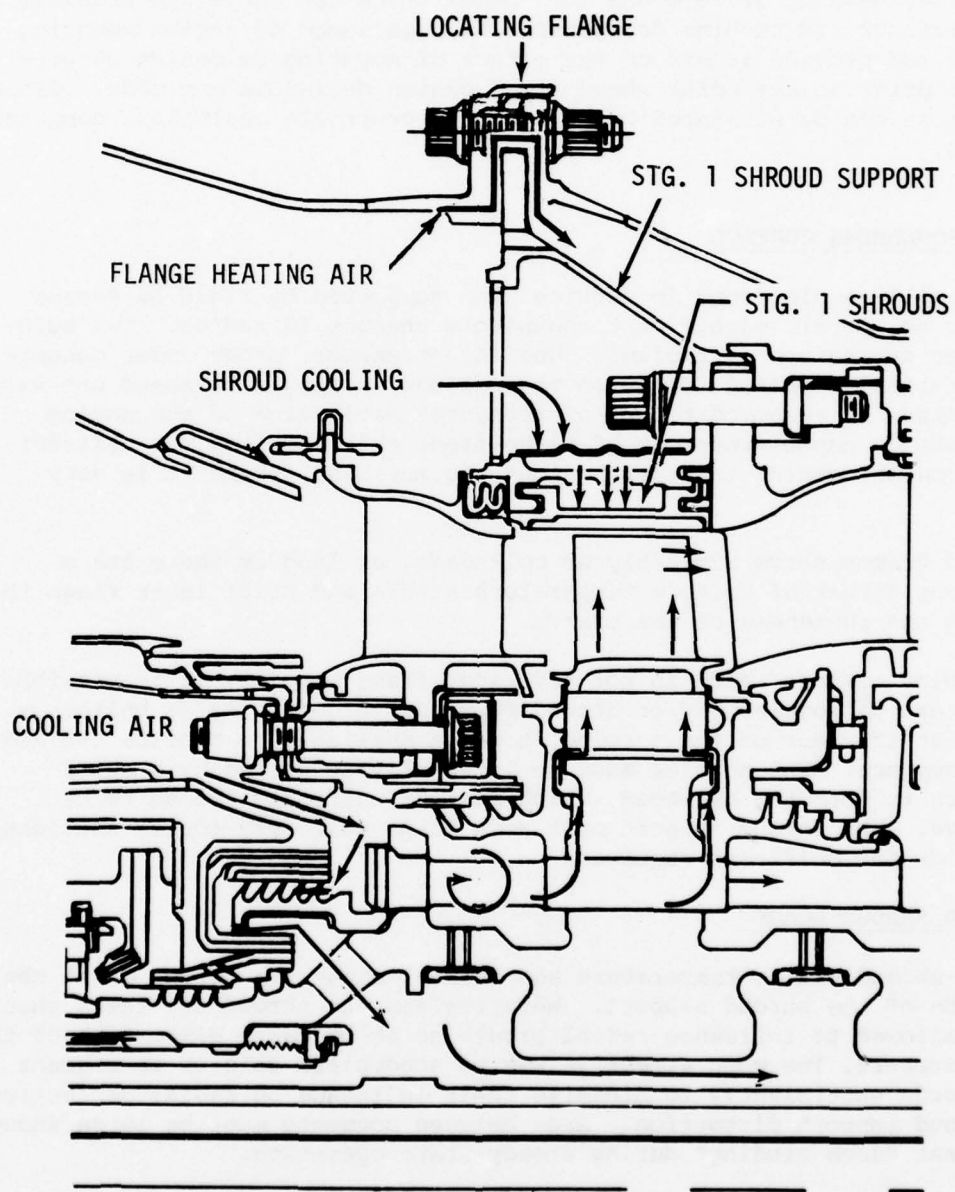
Figure 2. Stage 1 Disk and Stage 1 Shroud Cooling Systems.

2. Controlling rotor cooling with a known source and quantity of air results in more predictable rotor growth (and clearance). If disks are not cooled by forced convection, their temperature distribution due to free convection is difficult to predict. For this reason, free convection cooling is often avoided. If free convection heat transfer is unavoidable, disk cavity test data on similar designs should be consulted as a guide. Free convection heat transfer on a large disk results in slow temperature response to throttle bursts and chops and can cause poor rotor-to-stator match. Forced convection compressor discharge cooling air, which circulates on the forward and aft side of the disk faces and runs through the rim dovetail slots before entering the blade dovetails, is an effective means of rotor cooling. Additionally, inner balance piston leakage air to cool the disk ID is utilized. A rotor-forced convection cooling scheme is shown in Figure 2.

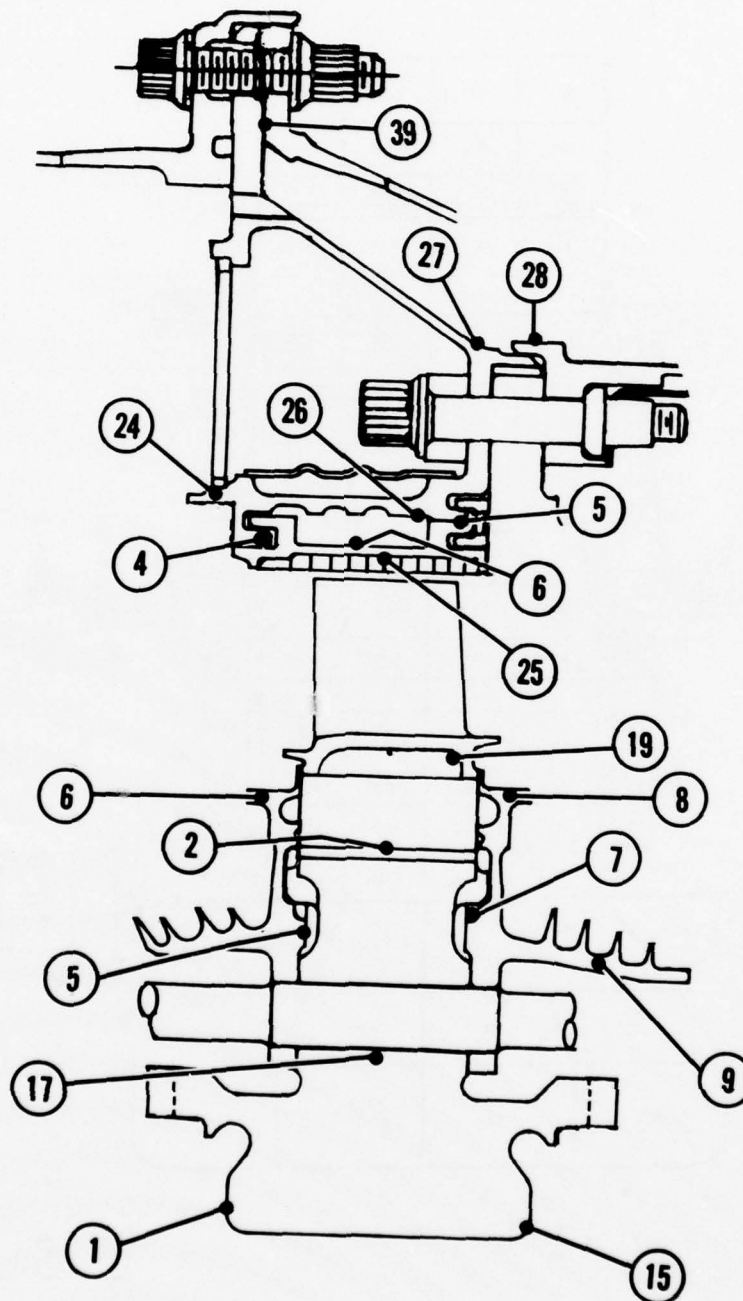
Figure 3. Location of Thermocouples on YT700 Engine Serial No. 002-3A.

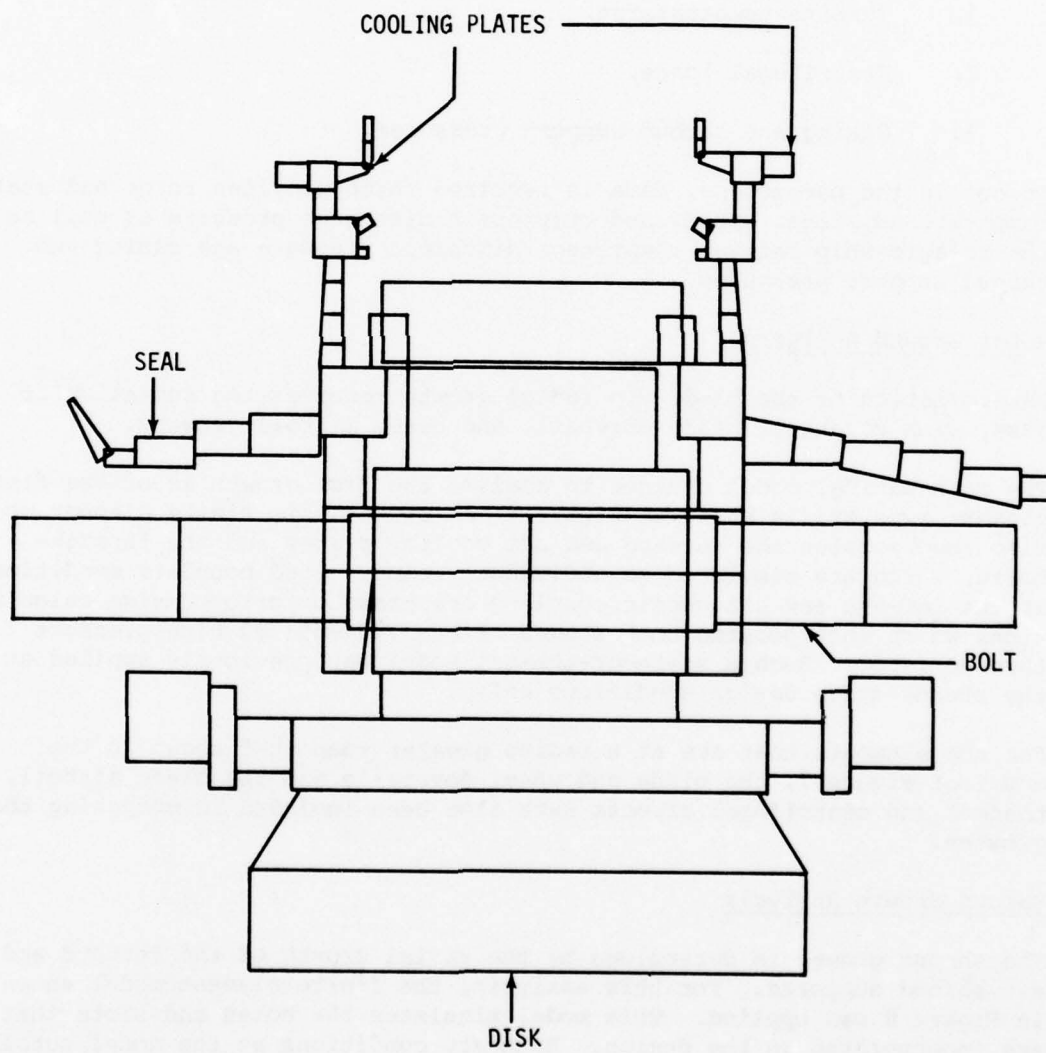
Figure 7. Stage 1 High-Pressure Turbine Rotor Finite Element Model.

The mathematical model devised to analyze the disk growth is of the finite element type and is shown in Figure 7. As shown, this finite element model also incorporates the forward and aft cooling plates and the through-bolts, which are simulated as individual beams. Load boundary conditions at the forward and aft curvic coupling are based on prior design calculations which incorporated both stages of the T700-GE-700 high-pressure turbine rotor. Such a state-of-the-art model was previously applied at the steady-state design conditions only.

For the elements that are at a radius greater than that shown in the model of Figure 7, the blade and wheel dovetails and the blade airfoil, thermal and centrifugal effects have also been included in computing the growths.

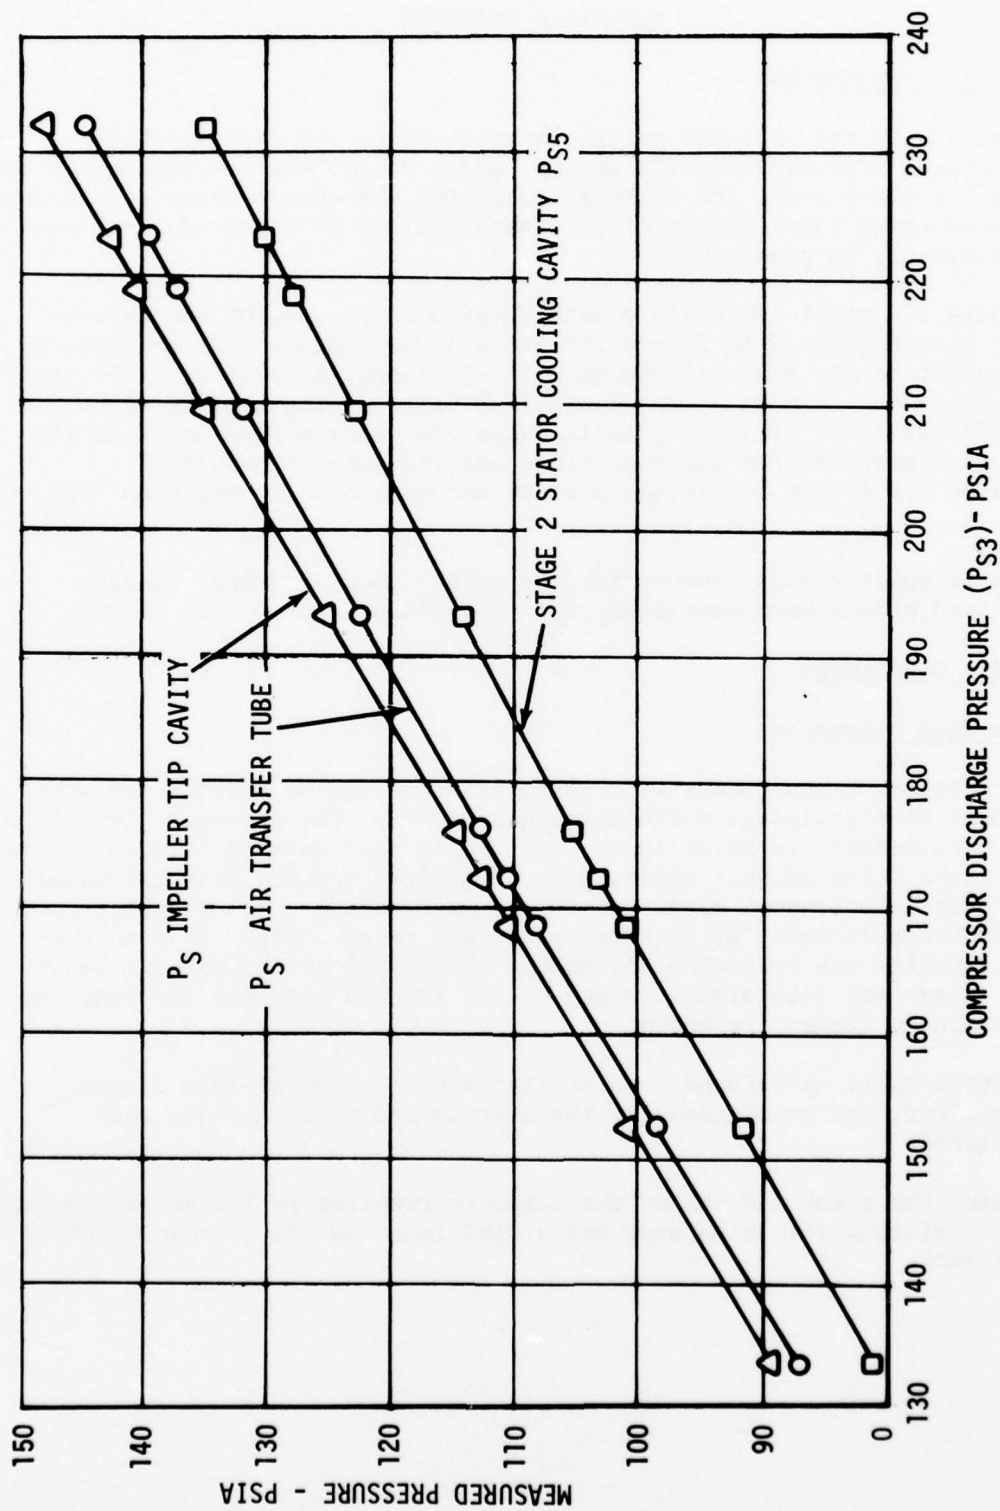
Figure 9. Relationship of Compressor Discharge Pressure to Static Cavity Pressure.

During an engine transient, a small lag or overshoot of cavity pressures versus P_{s3} is anticipated. Experience from other engines indicates that such lags or overshoots occur only within the first one or two seconds of a transient and have little effect on stator growth. Thus, the pressure relationships shown in Figure 9 were used to evaluate cavity pressures for transients as well as steady-state conditions.

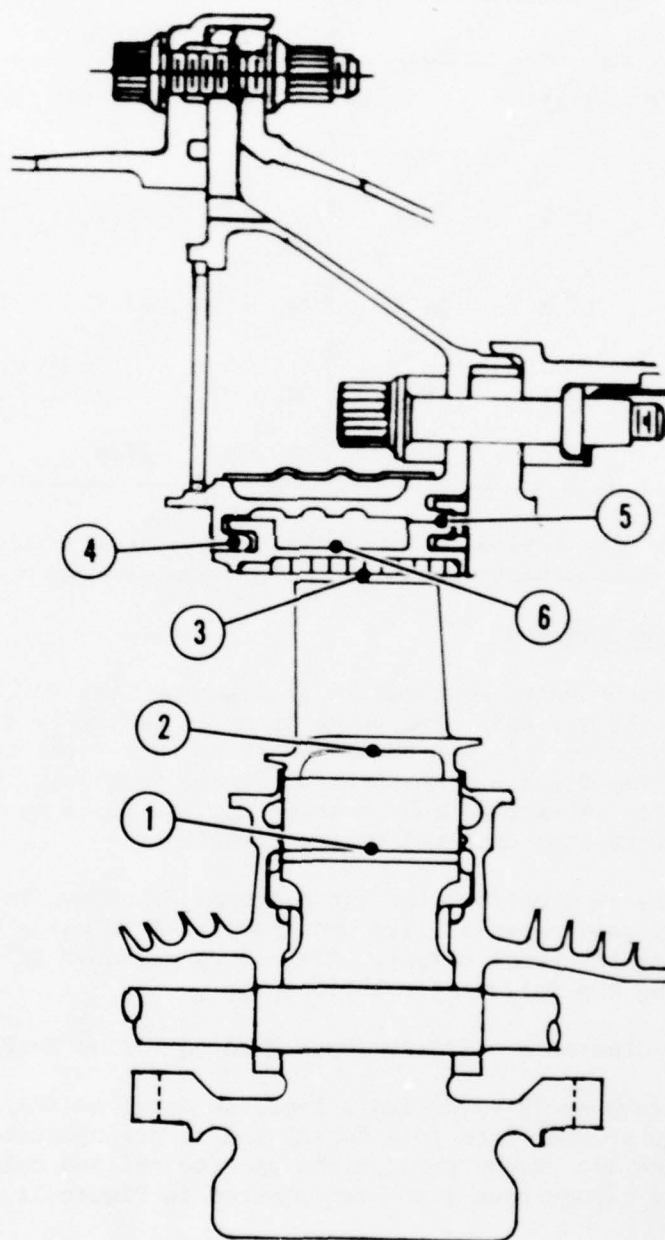
Figure 10. Radial Growth Calculation Points.

The results of the hardware growth analysis using the data matched temperatures from YT700-GE-700 Engine Serial No. 002-3A are summarized in Tables 1 through 5 for the selected transient and steady-state conditions. Figure 10 shows the location of the radial points at which the component growth history is presented.

In Figure 11, total rotor tip growth (Item 3 in Figure 10) and average shroud growth (Item 6 in Figure 10) are plotted. Since this analysis is independent of the measured engine cold clearance, a value of 0.014 inch was assumed for this data (the 0.014-inch value is the minimum allowable for YT700-GE-700). Thus, Figure 11 shows the minimum clearances of the YT700 configuration for the conditions analyzed with the minimum clearance 0.014 inch occurring about 10 seconds into a burst from idle to IRP.

TABLE 5. ANALYSIS OF STEADY-STATE CONDITIONS							
Condi- tion	Radial Growth ^(a) (mils)						Net Closure 3 - 6
	Rotor			Stator			
	Location 1	Location 2	Location 3	Location 4	Location 5	Location 6	
IDLE	8.2	10.9	16.1	10.9	15.4	13.2	+2.9
Ng= 39,400	13.8	17.6	24.1	17.6	22.7	20.2	+3.9
Ng= 42,575	16.9	20.5	30.0	21.2	27.3	24.3	+5.5
IRP	19.1	25.0	35.9	23.5	30.0	26.8	+9.1
(a) See Figure 10 for radial location definition

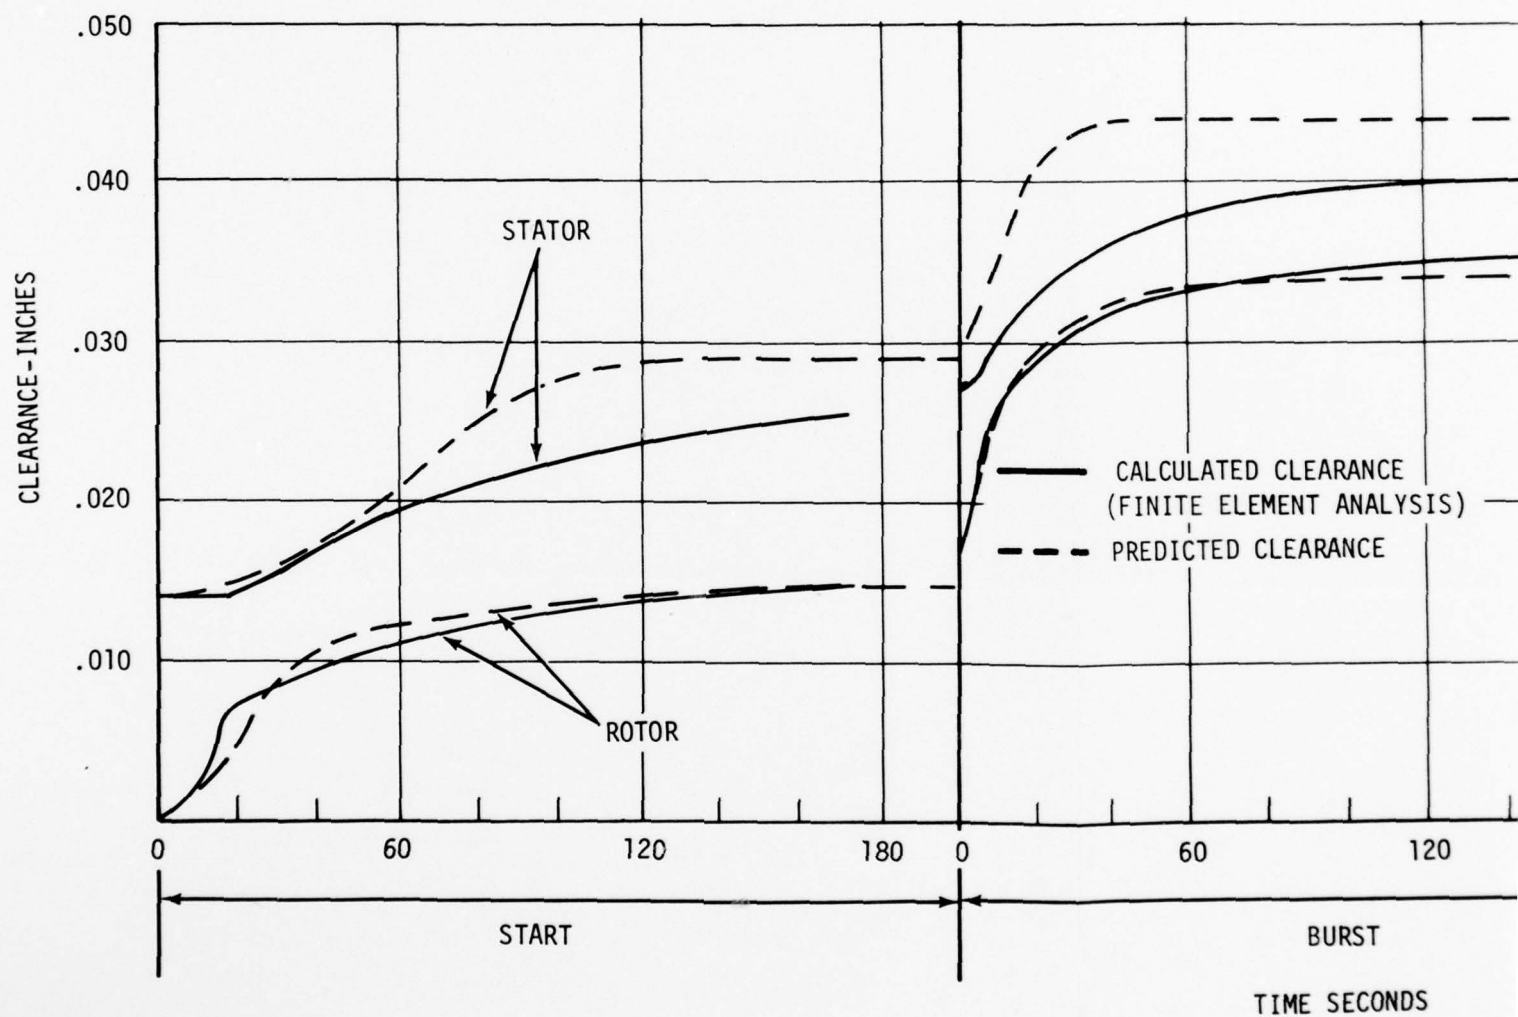
Figure 11. Stage 1 Blade Tip Clearance Analysis and Comparison With Previous Predictions.

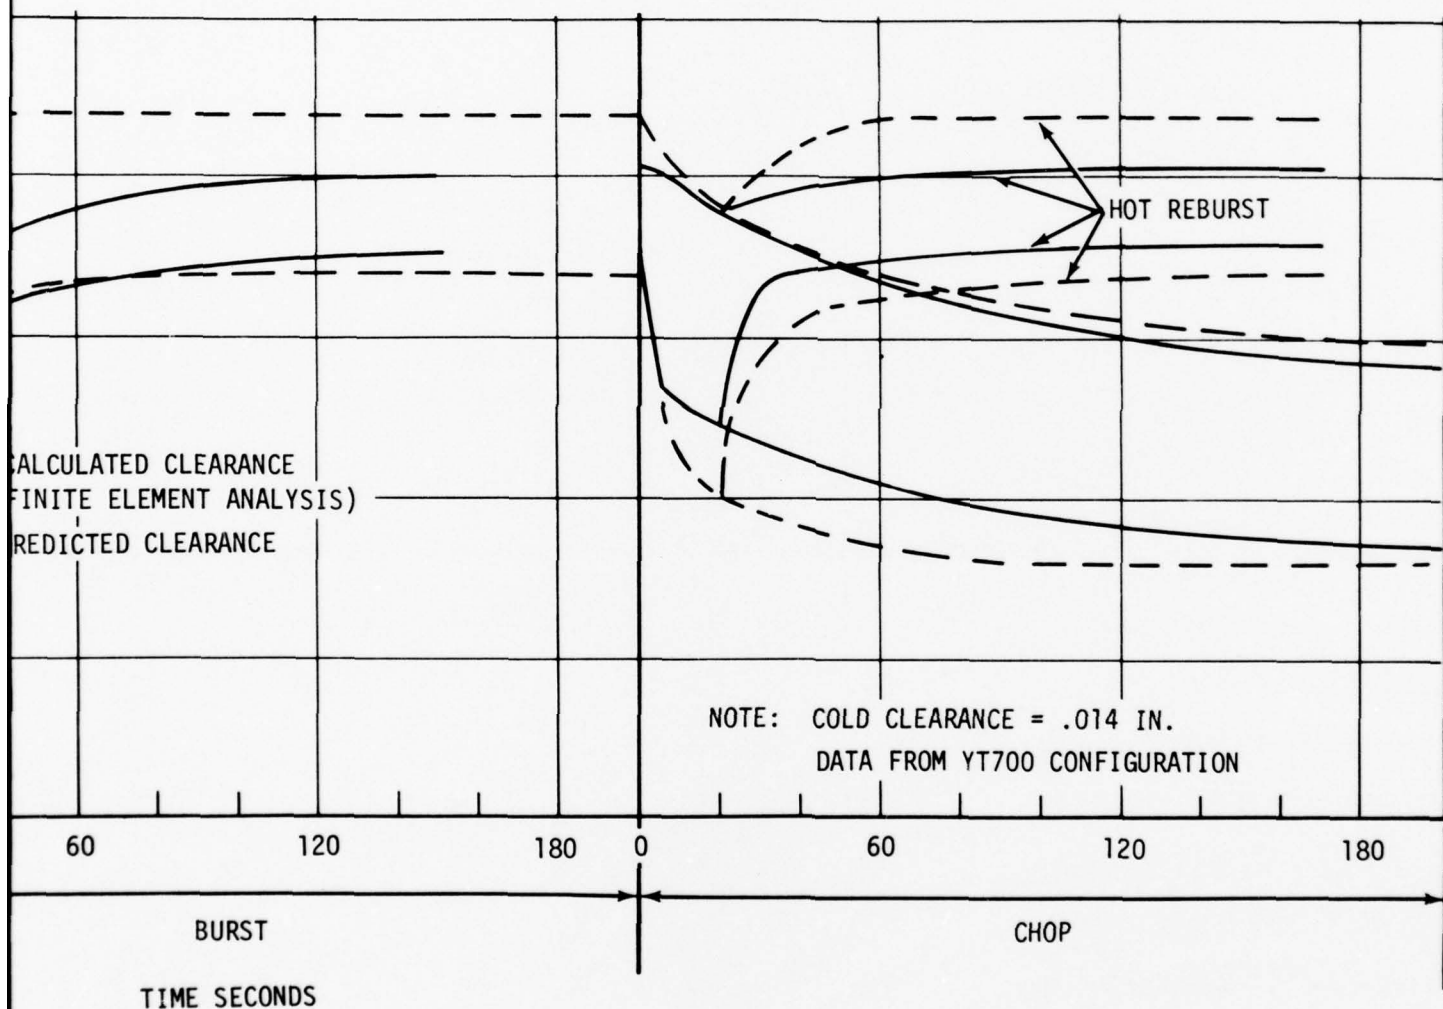
Figure 12. Calculated and Predicted Radial Closure.

The radial closure, shown in Figure 12, indicates that the character of the closure curves versus time is in reasonable agreement for both analyses, but for all conditions the closure predicted by the refined technique is larger. Related to engine operation this would indicate that operating clearances are smaller than previously predicted.

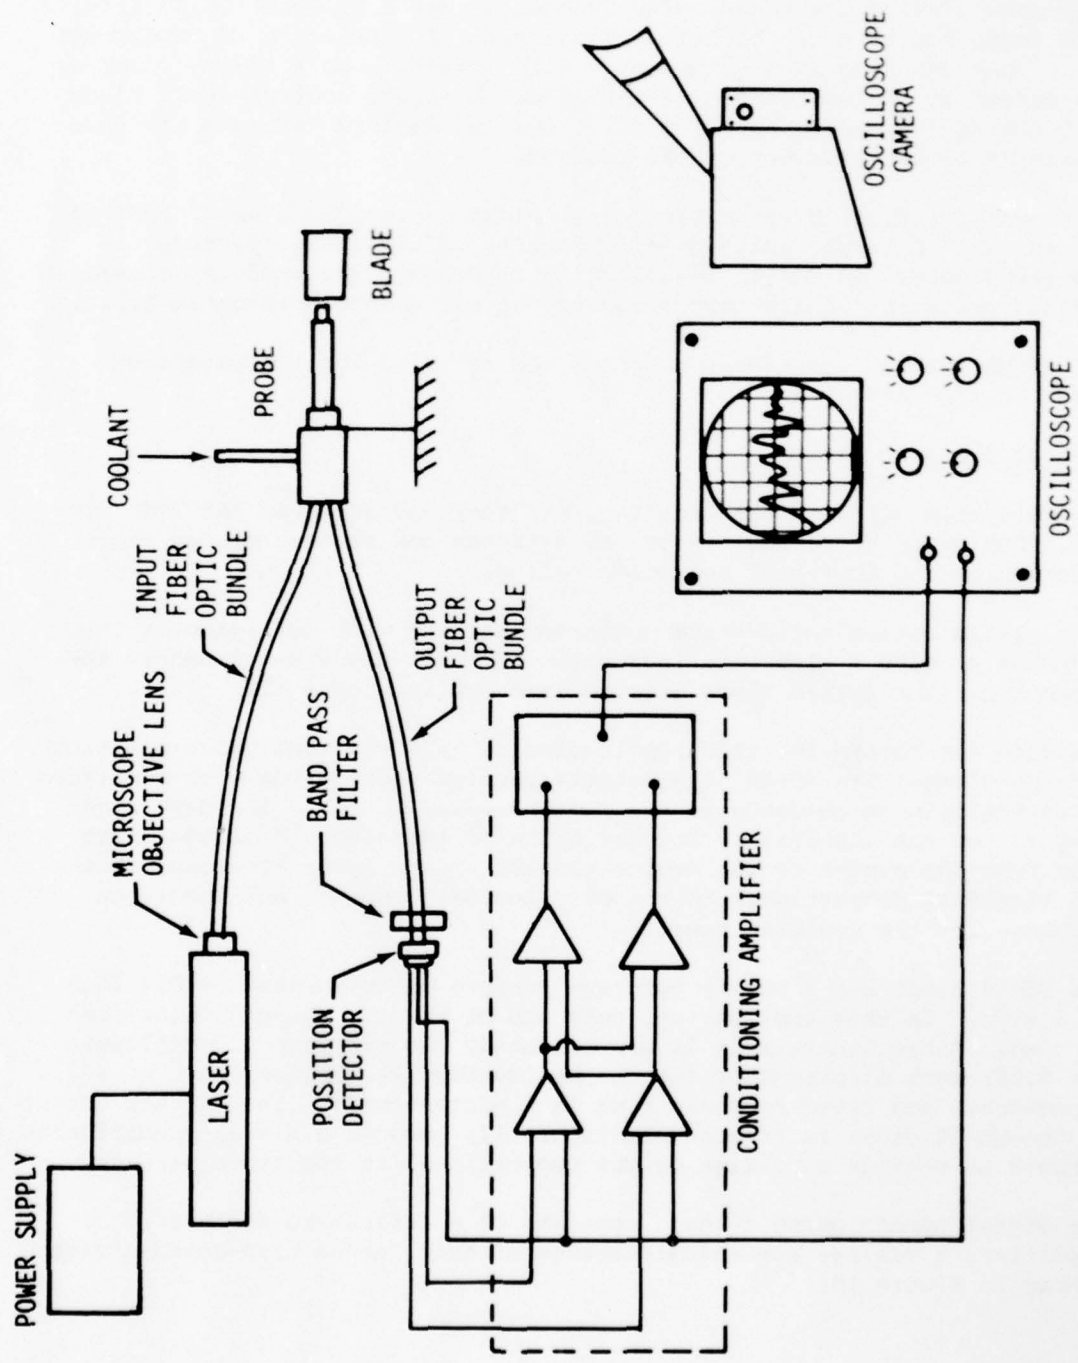
Figure 17. General Electric Tip Clearance Measurement System

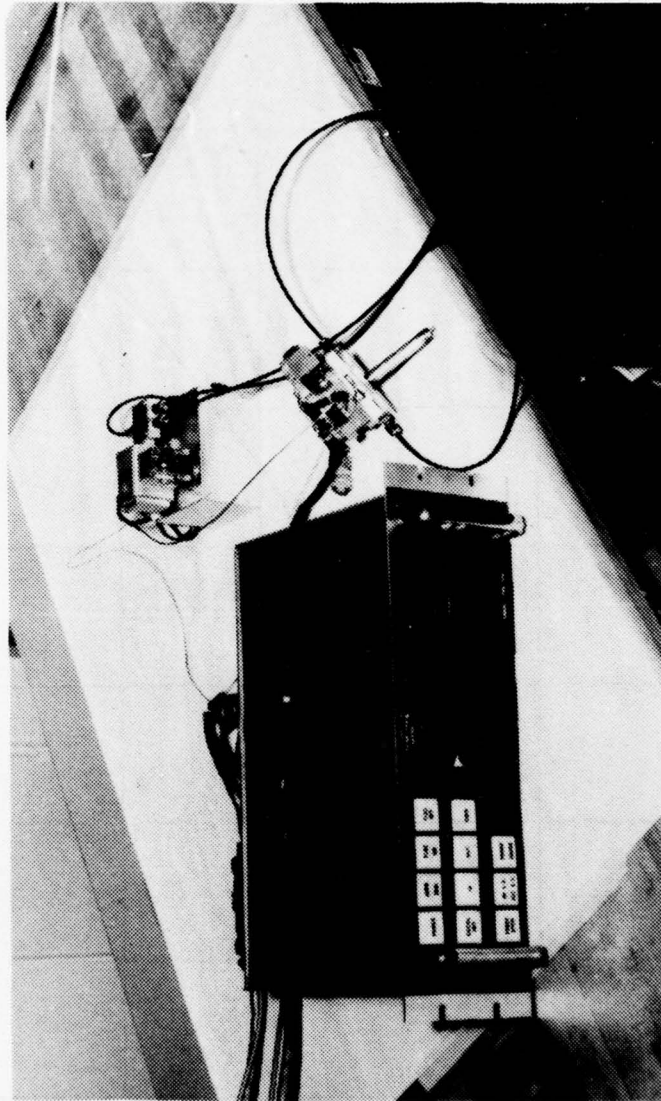
Figure 19. Touch Probe System.

A touch probe consists of a wire surrounded by coaxial layers of a magnesium oxide insulator and a protective outer shell. The probe is precisely driven until it contacts a reference surface (a moveable spring-loaded "flag" in the probe passage). A reading is then taken of this distance. Then the reference flag is turned aside and the probe is driven through a hole in the casing and shroud until it contacts the highest blade tip. A momentary electrical contact causes the control mechanism to stop the probe. A reading is taken, and the probe is withdrawn for another measurement. The difference of the two readings (minus the thickness of the flag plus casing and shroud) gives the actual minimum clearance. Figure 19 shows the touch probe system.

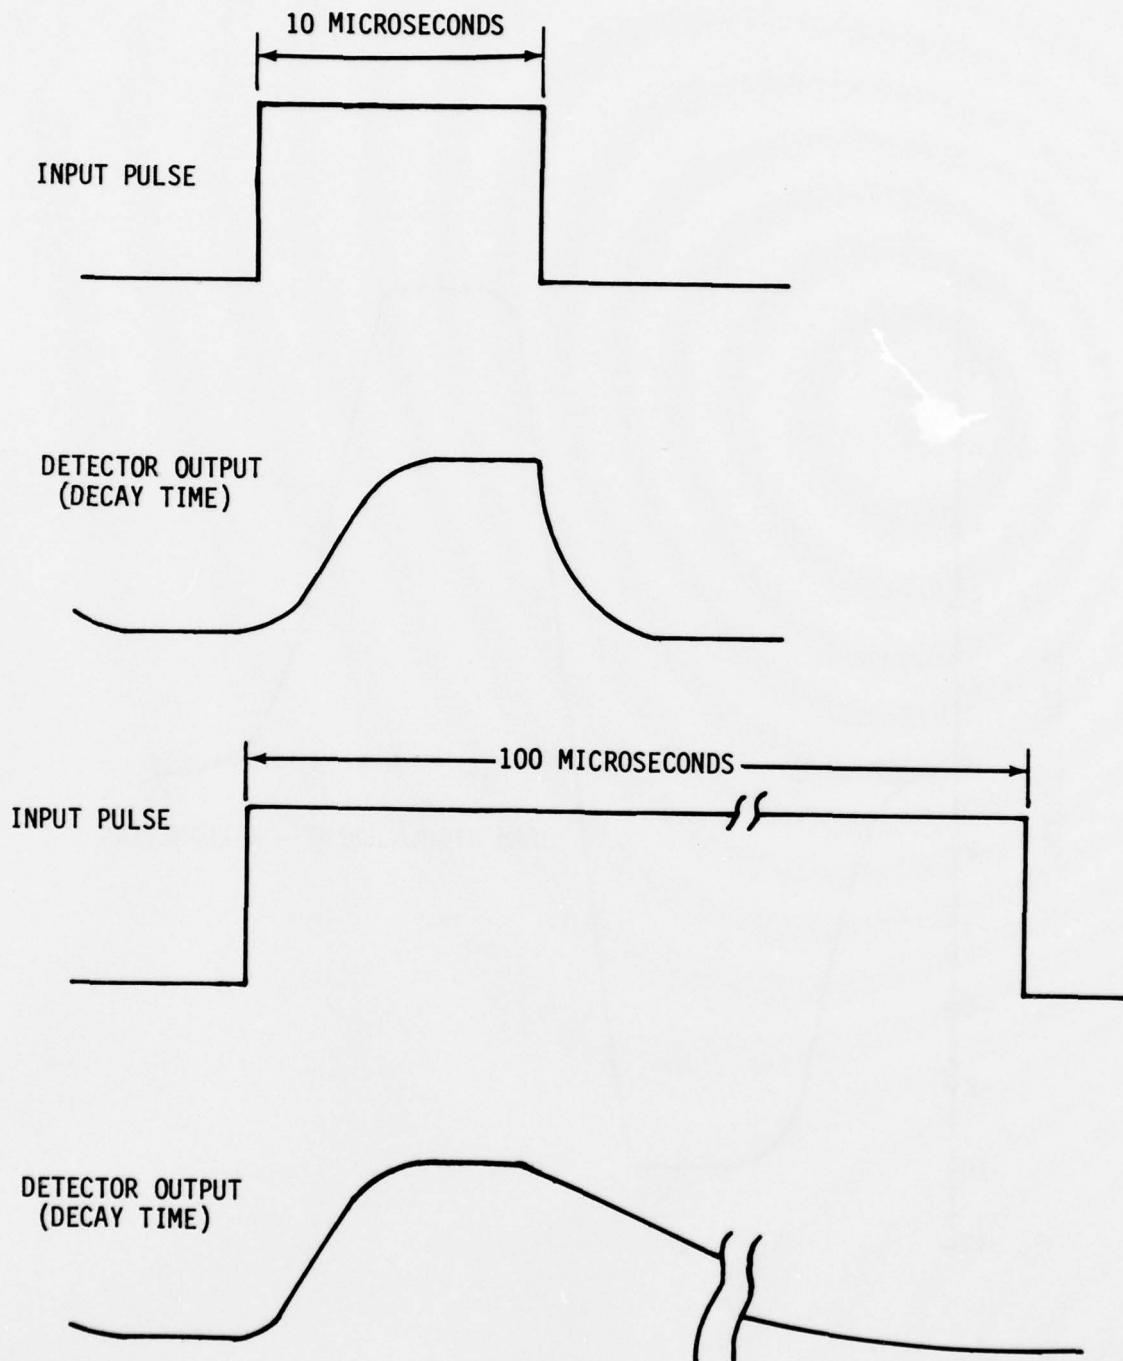
Figure 23. Decay Rate of SC-10 Detector.

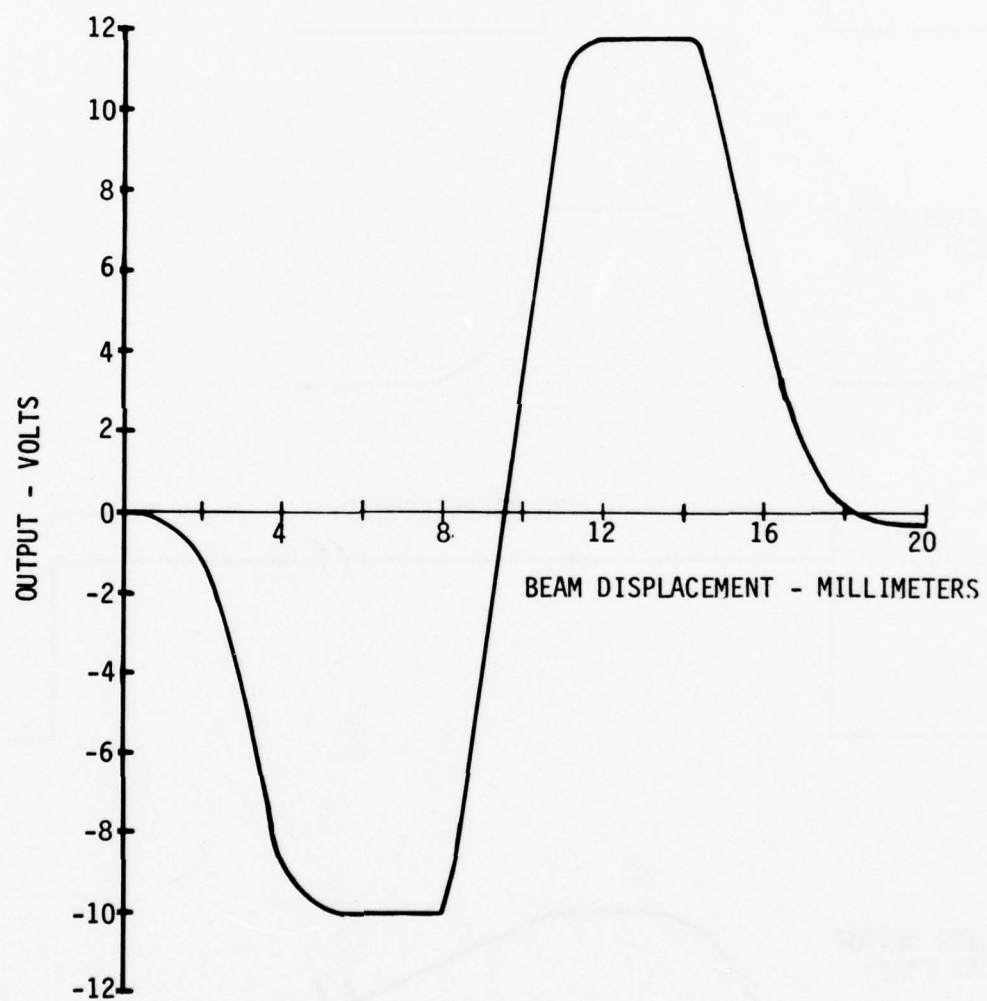
Figure 24. SC-10 Linearity Across Sensitive Area.

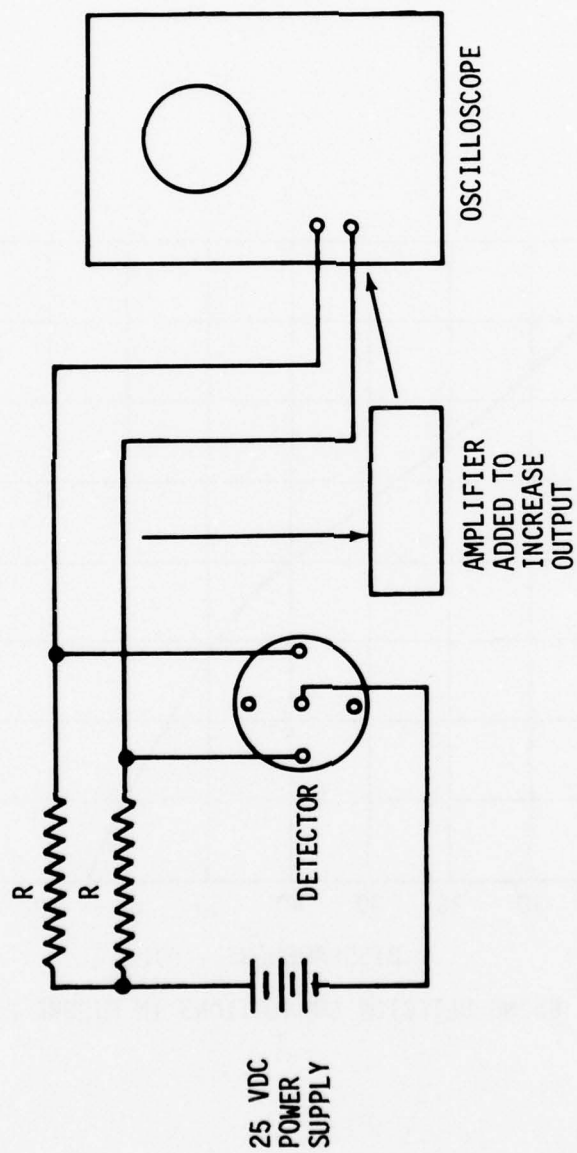
Figure 25. Detector Circuit Recommended by Manufacturer.

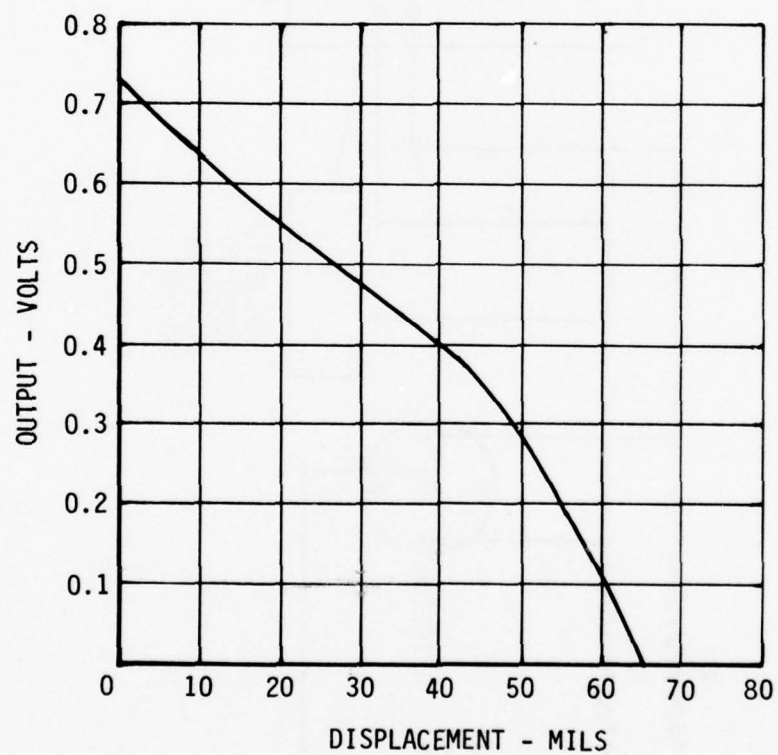
USING DETECTOR CONNECTIONS IN FIGURE 25

Figure 26. Calibration of Detector Circuit.

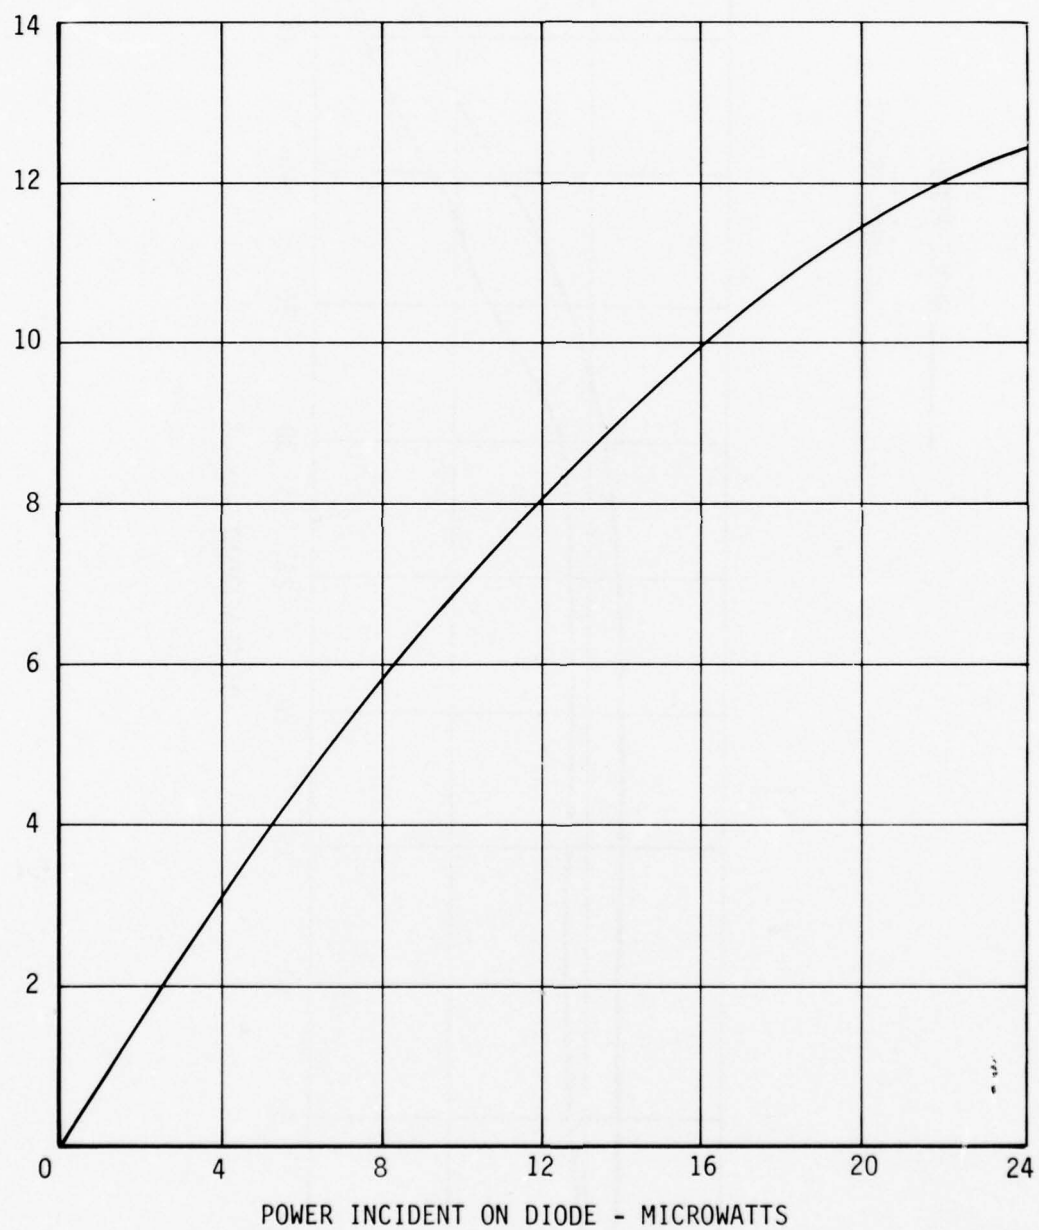
Figure 32. Effect of Beam Intensity on SC-10 Detector.

The intensity changes clearly affect the output of the SC-10 detector as shown in Figure 32. This intensity change may be caused by many factors; the most important being the reflectivity of the target material.

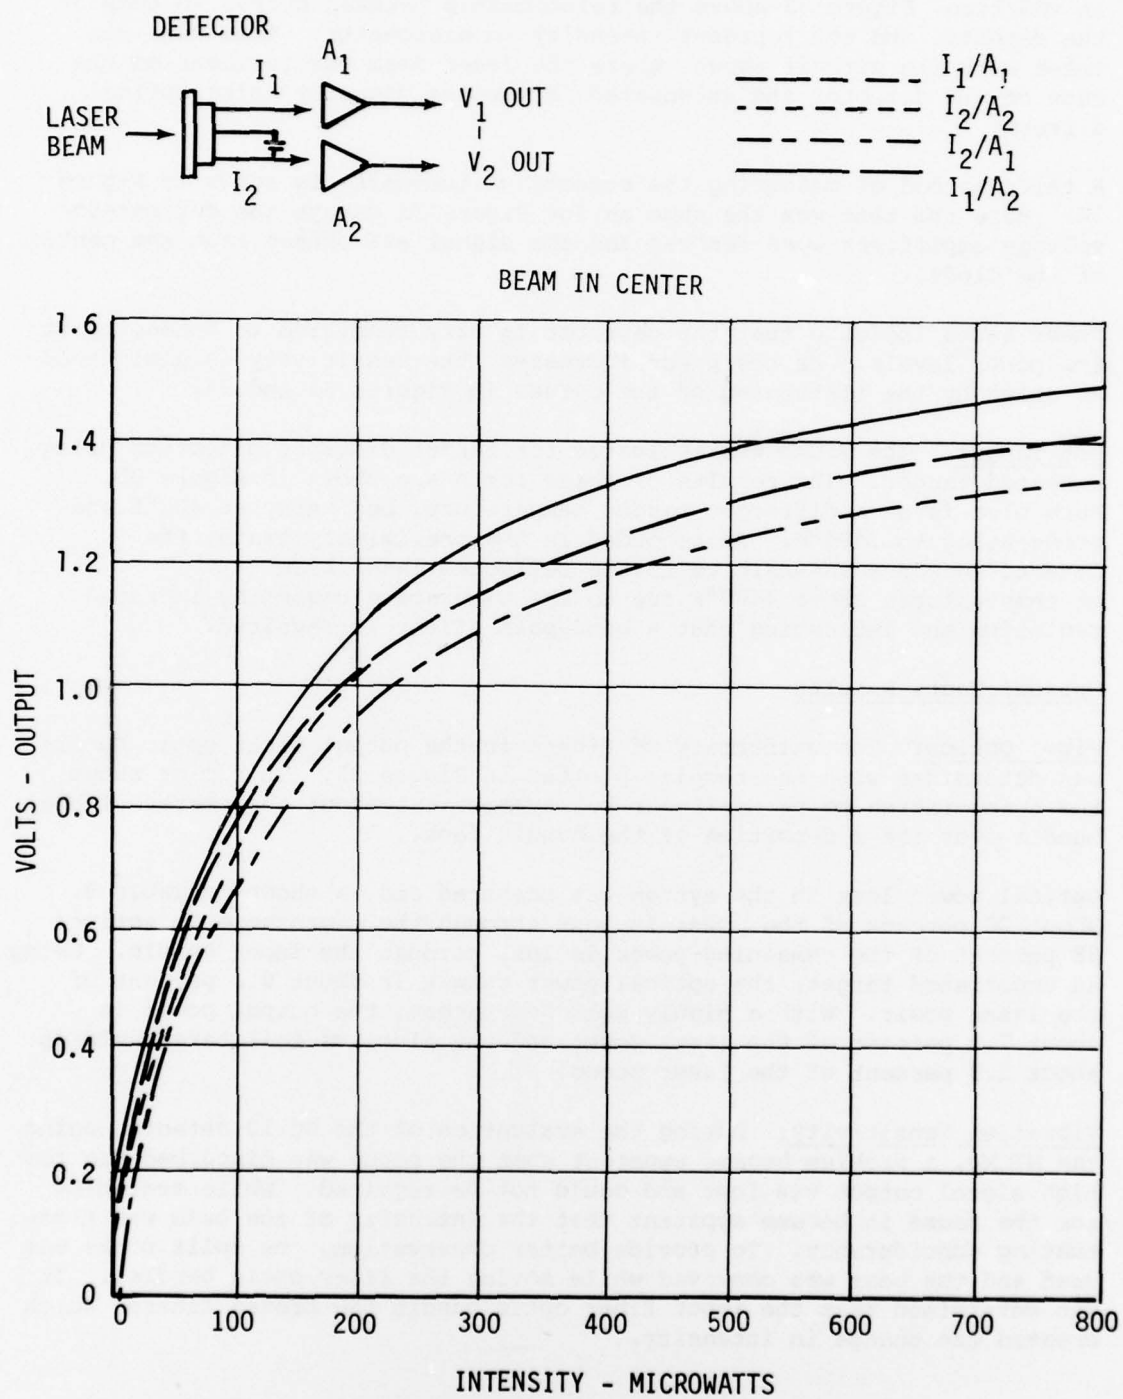
Figure 33. Detector Voltage Output.

In addition, Figure 33 shows the relationship between output voltage of the detector and the incident intensity in microwatts. This data was taken with the circuit shown, where the laser beam was incident on the face of the detector and attenuated in various steps by using optical filters.

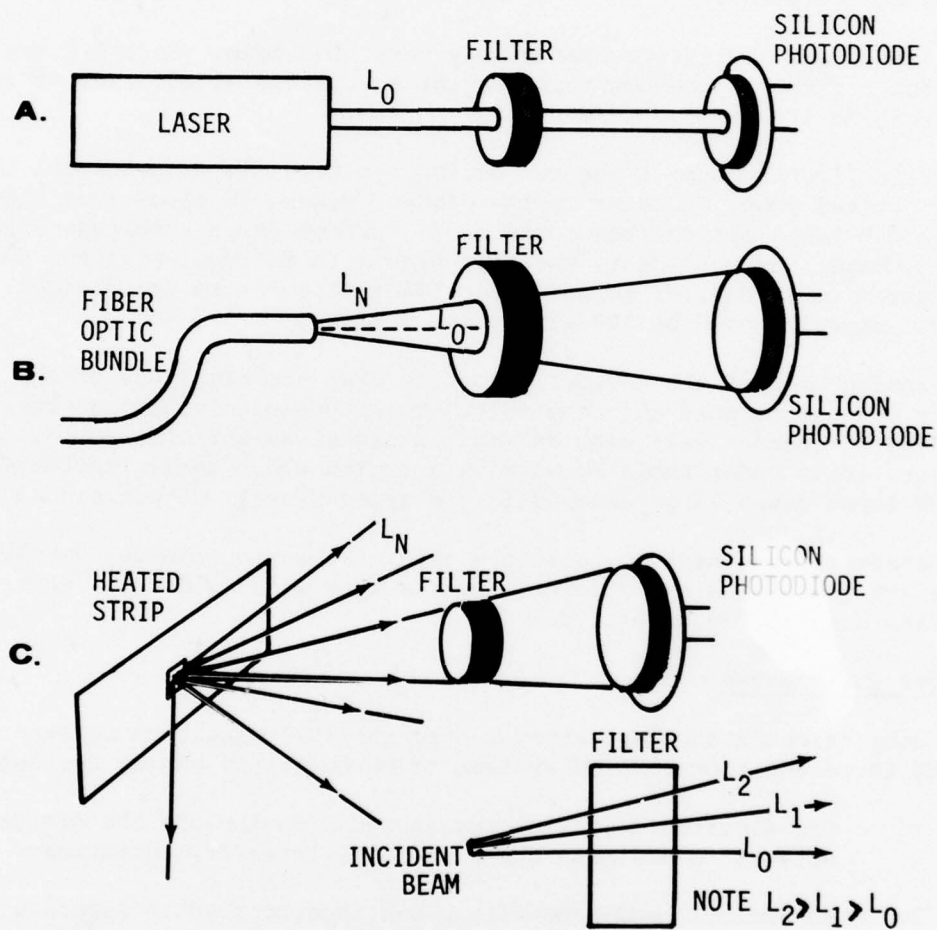
- A.** FOR COLLIMATED LIGHT, 632.8 NANOMETERS (40%)
- B.** FOR DIVERGENT LIGHT, 632.8 NANOMETERS (25%)
- C.** FOR DIVERGENT LIGHT, 400 to 2000 NANOMETERS
(25% FOR STANDARD INTERFERENCE FILTER)
(1.5% FOR NARROW BAND-PASS FILTER)

Figure 37. Efficiency of Band-Pass Filter.

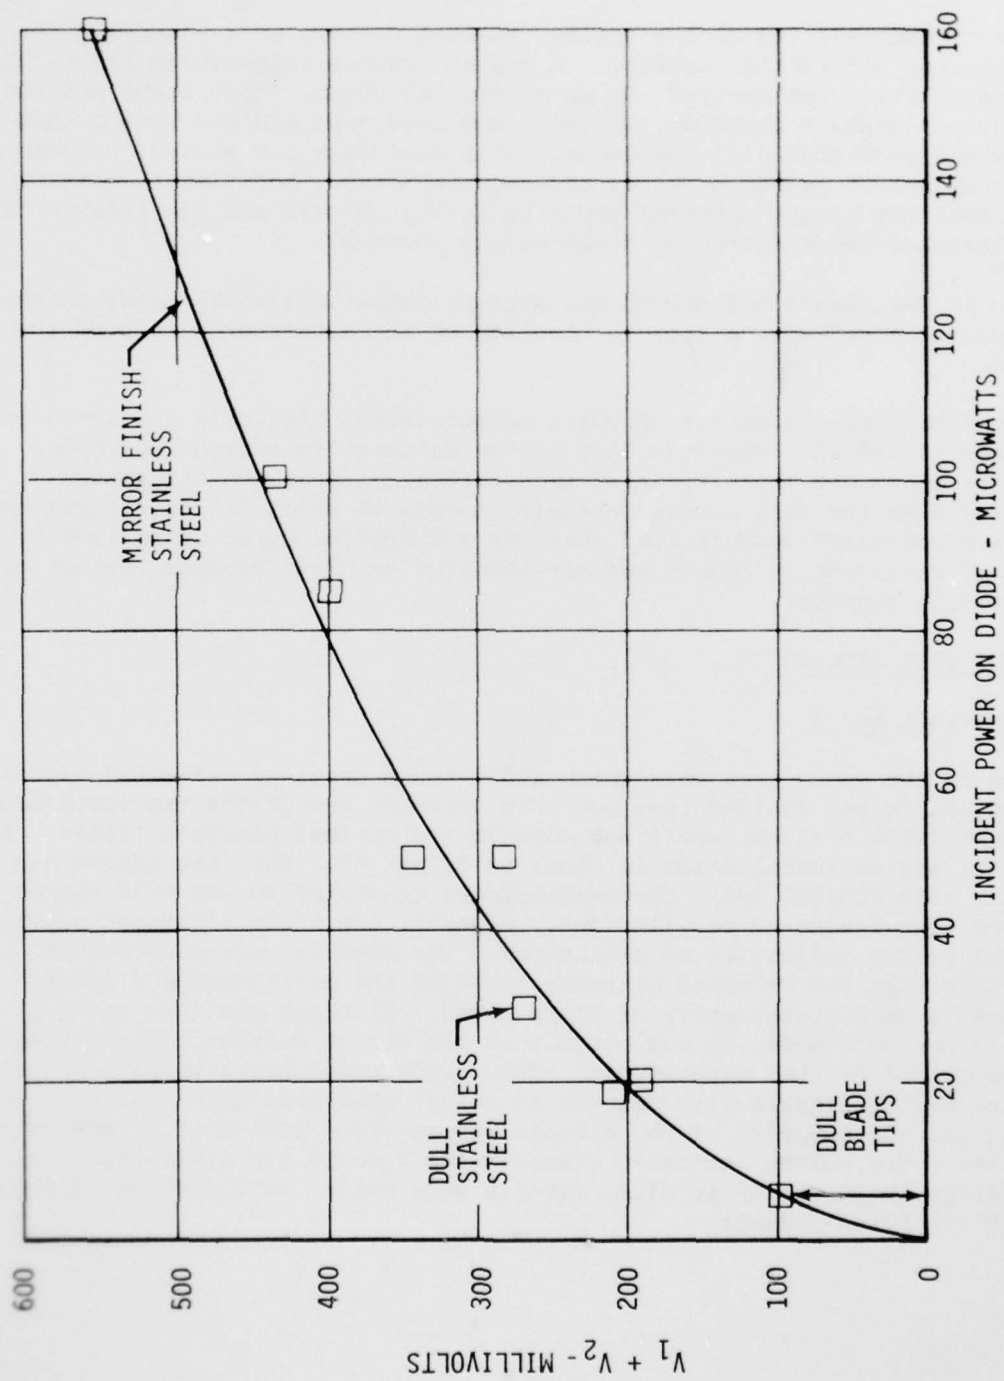
Figure 38. Amplifier Response to Optical Power Incident on Diode.
